USAARL Report No. 2009-02

# Noise and Reverberation Reduction in Post Chapel Activity Room

By Adrianus J.M. Houtsma

U.S. Army  
Aeromedical Research  
Laboratory

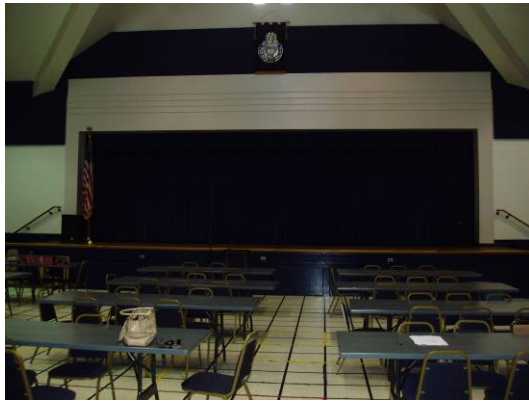
Figure 1a. Chapel Annex, north wall, with stage closed off by curtain.

The overhead ceiling baffle proposal was never executed but, instead, an additional amount (about 1000 ft<sup>2</sup>) of wall-mounted sound-absorbing panel material was added to the rear and side walls above the existing acoustic paneling. Figures 1a- through 1d provide an illustration of the four walls and their acoustical treatment; the dark-blue band represents the newly-installed added acoustic paneling. In June 2007, a second set of reverberation time measurements was made to quantitatively document the subjective acoustic improvement reported by the activity room users. This report details the equipment and methods used, the raw acoustic results, and the mathematics of extracting RT<sub>60</sub> reverberation times (i.e., the time required for a sound to decay by 60 decibels [db] in a space after the sound source is turned off). The report is also intended to demonstrate a relatively simple method to take such measurements using general-purpose equipment and dedicated signal processing software.

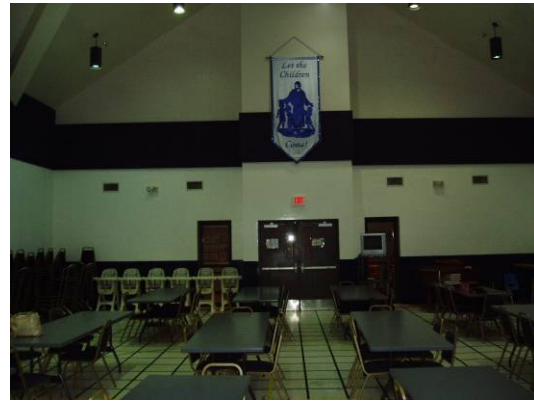
Figure 1c. West (left side) wall.

The lower white-colored wall segments of rear and side walls show the original sound-absorbing paneling. The dark-blue covered wall segments are the newly added sound-absorbing wall panels. The white-colored areas above the blue panels are acoustically untreated brick wall segments.

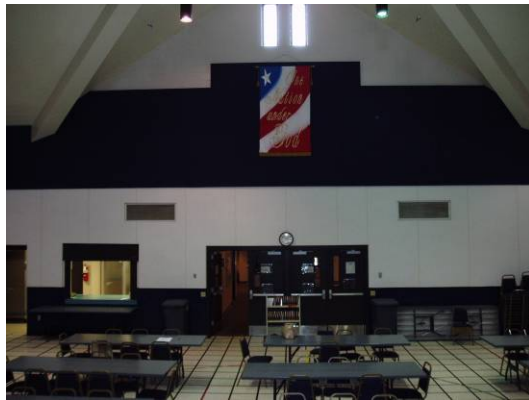
Figure 1b. South (rear) wall.

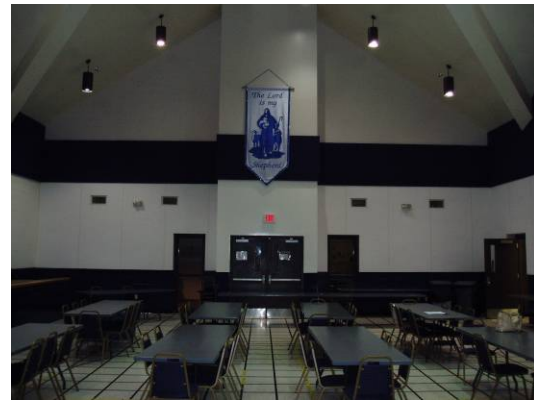
Figure 1d. East (right side) wall.
